# Loss of control during taxi and ground collision involving SAAB 340B, A3-PUA

Fua'amotu International Airport, Tonga, on 8 December 2023

**Chief Investigator - Tonga Civil Aviation Office Aviation Safety Report**  
Aviation Occurrence Investigation  
AO-2023-001  
Final

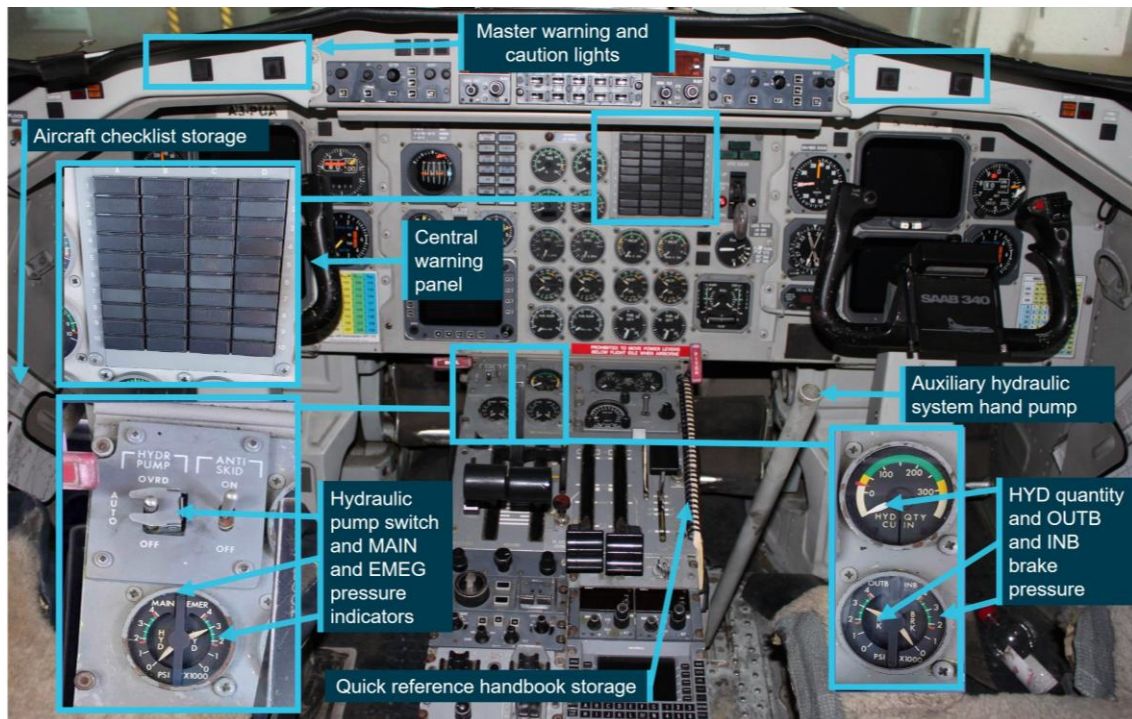
**Figure 2: Inset hydraulic panel photos taken in-flight showing the observed indications**

The investigation found that a tripped circuit breaker had removed power from the hydraulic quantity indicator, as well as the main hydraulic accumulator pressure and inboard wheel brakes accumulator pressure indicators. It could not be determined when the circuit breaker tripped on the flight, however, this was not detected by the first officer while performing the initial hydraulic system troubleshooting, most likely due to an expectancy error. The flight crew subsequently misidentified the indication issue as a hydraulic leak, and commenced the abnormal checklist for hydraulic fluid loss, which included turning off the hydraulic pump (the hydraulic system was operating normally until that time). As a result, no hydraulic pressure was automatically provided to the hydraulic system. While the crew reviewed sections of the hydraulic loss abnormal checklist during the emergency, they did not read all parts of the checklist. Further, the flight crew only had a basic understanding of the aircraft's hydraulic system. As a result, the flight crew had an incomplete appreciation of the limitations of the inoperative hydraulics system.

- hydraulic quantity – 0 in<sup>3</sup>
- main hydraulic accumulator pressure – 0 psi
- auxiliary hydraulic accumulator pressure – 3,000 psi
- inboard (INB) wheel brake accumulator pressure – 0 psi
- outboard (OUTB) wheel brake accumulator pressure – 3,000 psi.

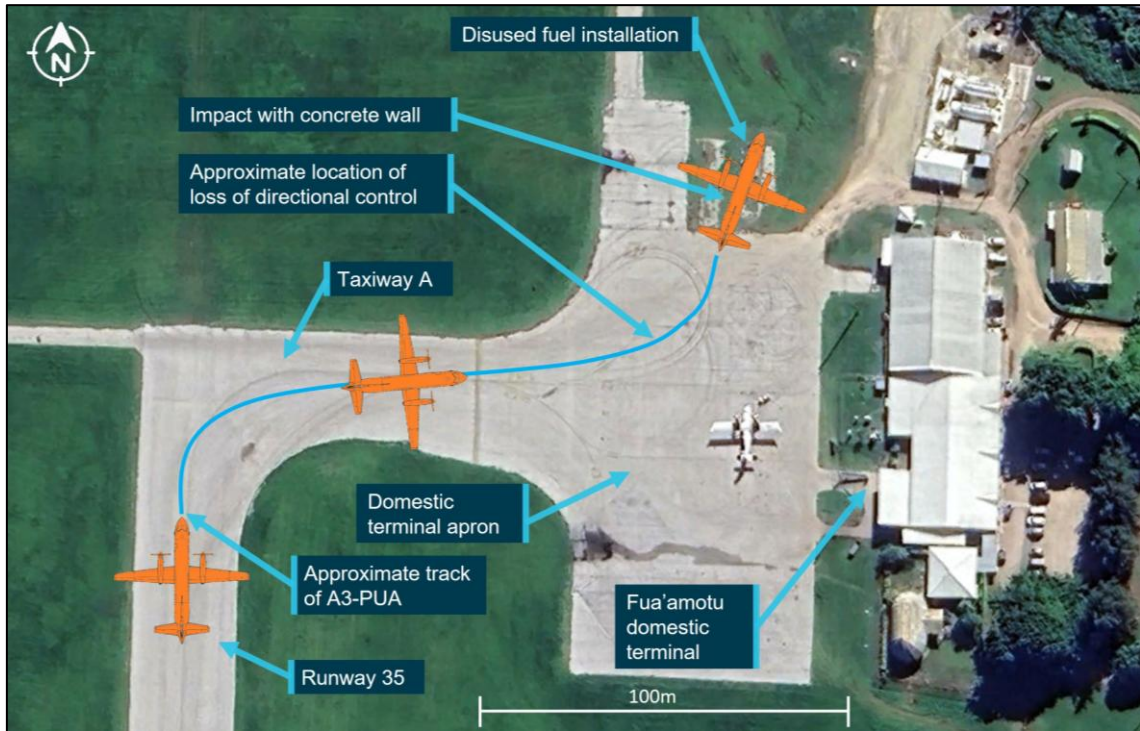
**Figure 4: Approximate taxi path and point of loss of control**

The FO asked the captain if they would try taxiing, and the captain said they would see. The crew were able to taxi the aircraft using the rudder to steer and used available wheel brakes for speed control. They taxied along runway 35, and then taxiway 'Alpha', onto the domestic terminal apron. As they approached the terminal, and before commencing their final right turn, the captain identified that they had no brakes, and the aircraft departed the taxiway (Figure 4). The FO shut down the engines with the condition levers shortly before the right landing gear leg impacted a disused concrete bund<sup>5</sup> area, that was part of a previous refuelling installation, at about 1400. The aircraft veered to the right, and the right landing gear collapsed.

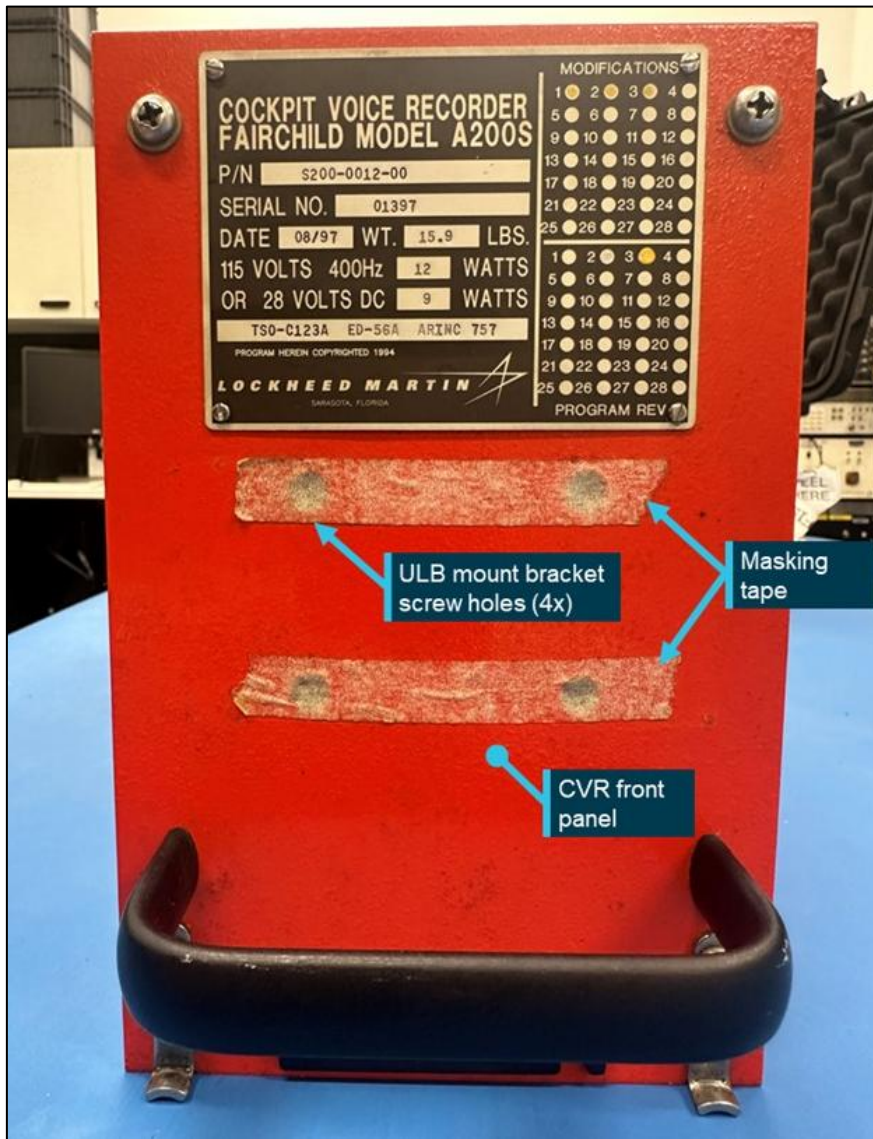
Figure 6: CVR with masking tape over ULB mounting holes

When the CVR was received from the operator, ATSB identified that there was no ULB or ULB mount bracket attached, and there was masking tape over the mounting bracket screw holes in the front panel (Figure 6). While it is not unusual to remove the ULB from flight recorders for transport due to the ULB containing a lithium battery, this recorder had indications that the ULB had not been attached to the CVR at the time of the accident.

As identified during the data recovery for the CVR, it was noted that the ULB had not been installed on the CVR for quite some time. Investigators could not identify in the aircraft's paperwork when the ULB was removed. It was however identified by the avionics LAME as being missing during a 2-yearly avionics inspection, albeit documenting that it was missing from the FDR. The engineer performing the inspection recalled asking the chief engineer about the ULB being missing. They were told that the battery had expired and had been removed for battery replacement. The operator confirmed to investigators that no follow-up action was taken to order a replacement ULB and mount or enter it into the aircraft's MEL.

As the ULB was missing from the CVR, this should have been entered as a defect in the MEL as the ULB was required to be fitted. Under the approved MEL (Figure 13), it was permissible for the CVR to be unserviceable for a maximum of 72 hours, and no more than 8 further flights, provided that the FDR was serviceable.

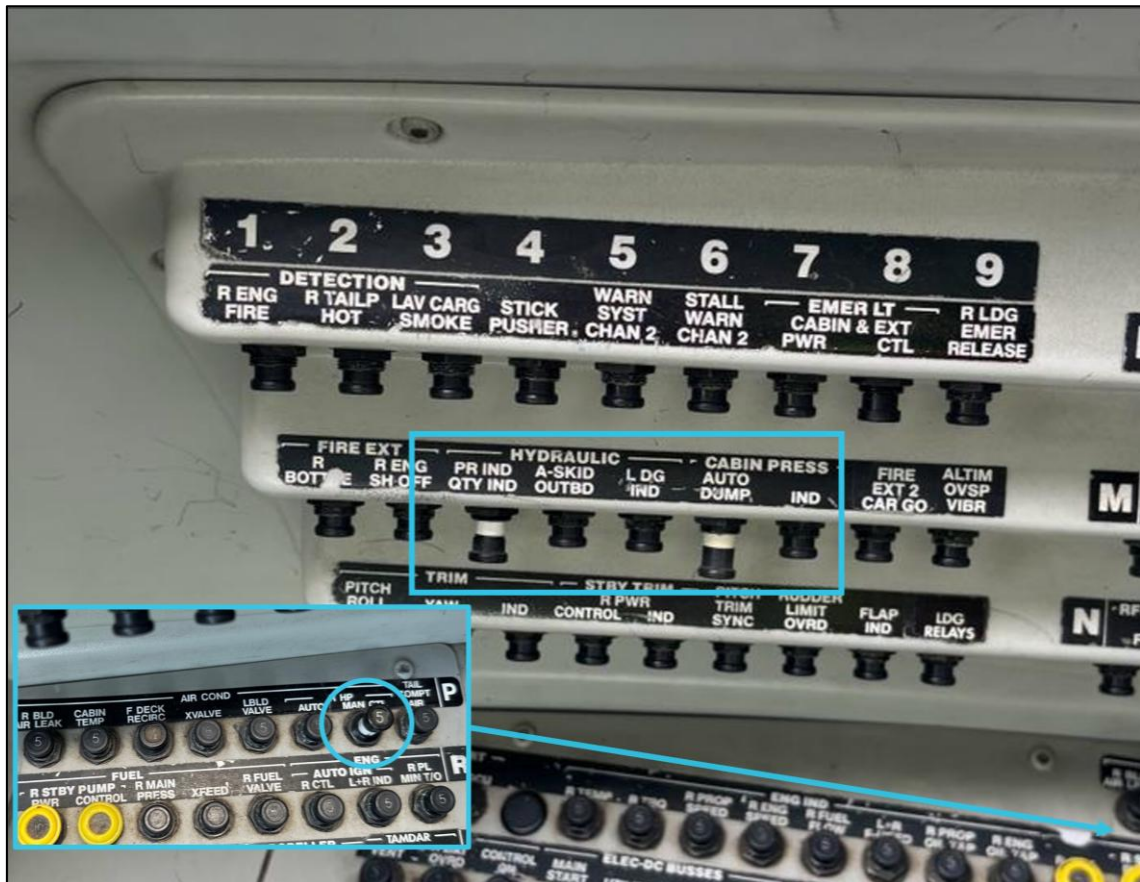
**Figure 7: Photo taken by the LAME shortly after the accident showing right circuit breaker panel with tripped circuit breakers**

The Lulutai Airlines LAME that maintained A3-PUA arrived shortly after the accident. They spent some time looking around the aircraft and taking photos. They did not identify any visible hydraulic leaks at that time. The LAME reported that they entered the flight deck and identified 2 tripped circuit breakers on the right circuit breaker panel (Figure 7). The tripped circuit breakers were:

- CABIN PRESS – AUTO DUMP
- HYDRAULIC – PR IND / QTY IND

The tripped 'CABIN PRESS – AUTO DUMP' and 'AIR COND – R HP MAN CONT' circuit breakers were most likely associated with wiring damage during the right landing gear leg collapse.

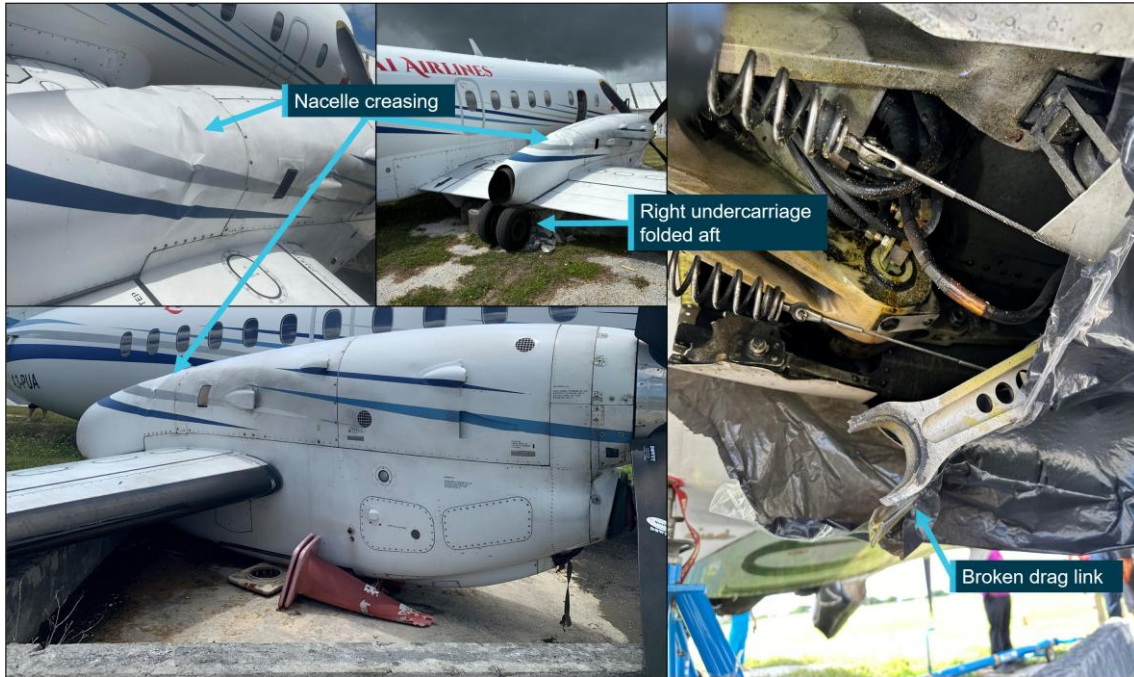
**Figure 8: Right landing gear damage and broken drag link**

- hydraulic pressure and quantity circuit breaker (HYDRAULIC – PR IND / QTY IND) tripped on the right circuit breaker panel
- cabin pressure auto dump circuit breaker (CABIN PRESS – AUTO DUMP) tripped on the right circuit breaker panel
- right air conditioner high pressure manual control circuit breaker (AIR COND – R HP MAN CONT) tripped on the right circuit breaker panel
- main hydraulic system reservoir quantity indicator in nose wheel well indicated empty
- auxiliary hydraulic system reservoir was full
- right main landing gear leg folded aft due to a broken drag link, most likely as a result of impacting the concrete wall (Figure 8)
- creasing in the aft region of the right engine nacelle, most likely from the right landing gear wheels impacting its lower surface (Figure 8)
- damage to 2 propeller blades on the right propeller (Figure 9)

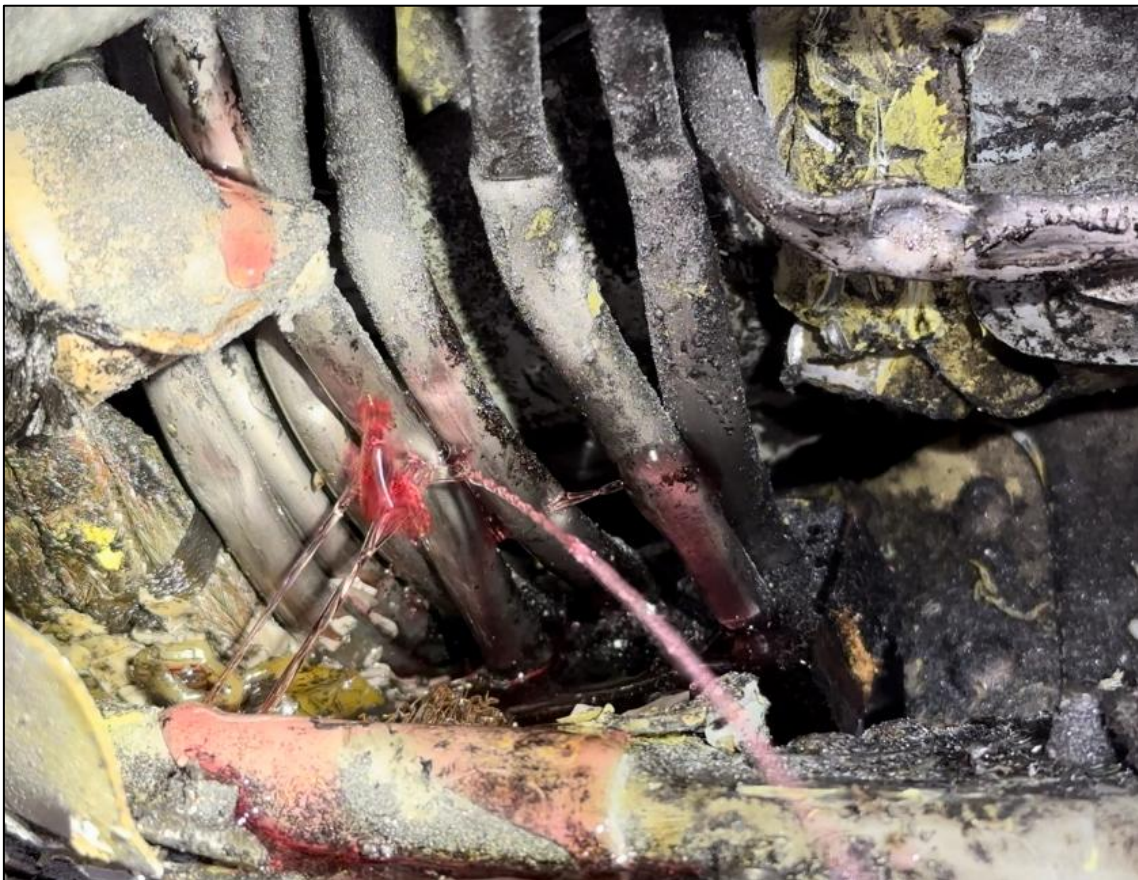
**Figure 10: Crushed, cracked, and leaking hydraulic pipes**

The LAME assisted the investigators by pressurising the hydraulic accumulators through the auxiliary hydraulic system hand pump, to check the system for potential hydraulic leaks. As each dump valve on each accumulator was activated, hydraulic fluid was observed leaking from an area above the right landing gear leg, and a constant flow was identified when the hand pump was actuated with the auxiliary hydraulic system pump selected to 'main accumulator'. The source of the leak was unable to be identified during this initial examination due to the position of the right landing gear leg and the subsequent structural damage in the nacelle.

After the initial on-site examination of the aircraft, the operator relocated it to their hangar facility. The CI and ATSB investigators revisited the aircraft on 14 February 2024 to conduct further examination to identify the source of the hydraulic leak. The operator had organised for the right landing gear leg to be removed to facilitate the examination. Damaged structure above where the landing gear leg and wheels had contacted the right nacelle was removed to provide access to the hydraulic plumbing. Further leak checks were carried out, and leaks were identified from several creased and cracked pipes (Figure 10). This damage was very likely associated with damage incurred during the accident sequence.

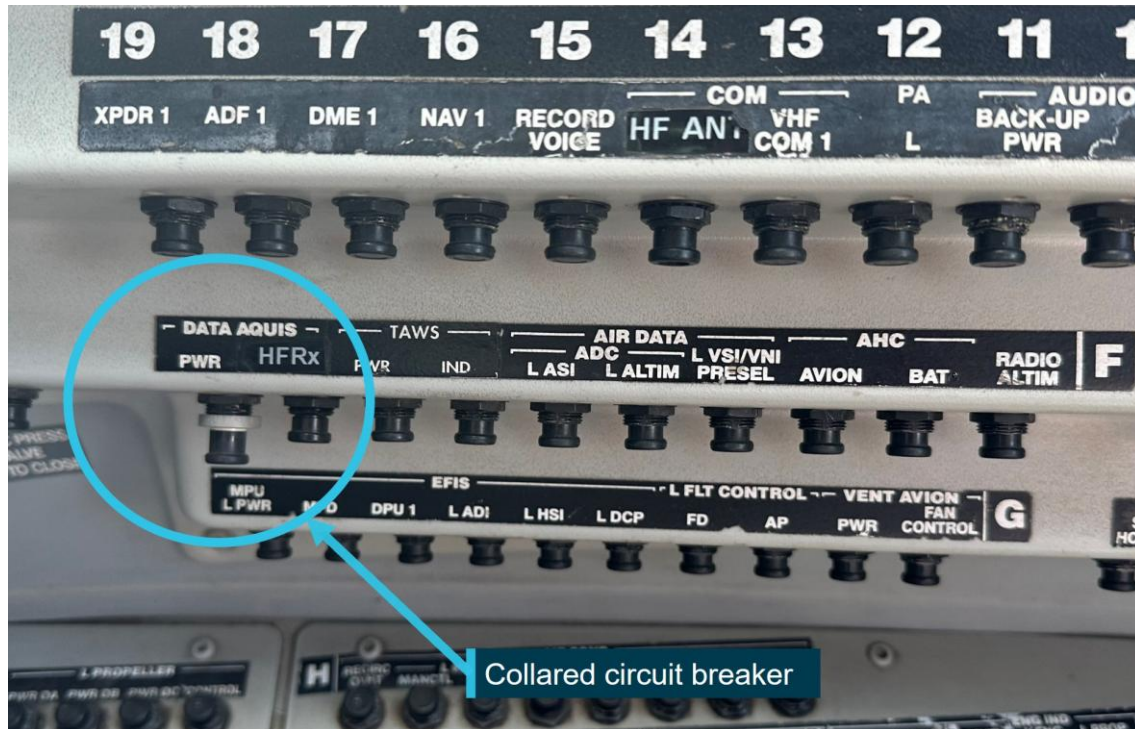
**Figure 12: Collared data acquisition power circuit breaker**

As a result of identifying that the FDR was not recording, an examination of the recording system was carried out by the Tonga Chief Investigator (CI) and ATSB investigators (Table 1). It was confirmed that the FDR was being provided power, so the FDAU system was examined. It was confirmed that no caution lights were illuminated on the flight data entry panel (FDEP), or on the FDAU indicating that no power was being supplied. Further examination found that the power circuit breaker for the FDAU (DATA AQUIS PWR) was extended (tripped) and was fitted with a locking collar to prevent it from being reset.

breaker was also collared to prevent flight crew from re-engaging the circuit breaker.) As the task was not recorded in the aircraft's technical log it could not be determined exactly when the circuit breaker was collared, although it is likely it occurred around 1 December 2023 while troubleshooting a reception issue with the HF radio. The circuit breaker was located on the left pilot's side circuit breaker panel, at location 'F19' (Figure 12).
